## The Repair of Preveneered Posterior Stainless Steel Crowns

**Abstract:** ***Purpose:** This study's purposes were to determine the shear bond strength (SBS) for and to perform dye penetration (microleakage) and scanning electron microscopy (SEM) evaluations of preveneered posterior stainless steel crowns (SSCs) that were repaired using 2 different materials. **Methods:** Twenty-two crowns were used. They were stored in artificial saliva for 30 days and then thermocycled. A force was applied on the crowns' occlusal surfaces until the original veneer material appeared to be fractured. The fracture types and SBS values were recorded. The crowns were then repaired using Panavia opaque cement and Tetric Flow or Monoopaque and Tetric Flow. Twenty of the repaired crowns were subjected to dye penetration and SBS tests, and the remaining 2 were evaluated using SEM. **Results:** Statistical analysis revealed no statistically significant differences in the results of either the SBS or the dye penetration test ( $P=.58$  and  $P=.38$ , respectively). A statistically significant difference was found between original and repaired crowns regarding fracture extent ( $P=.02$ ), but not failure

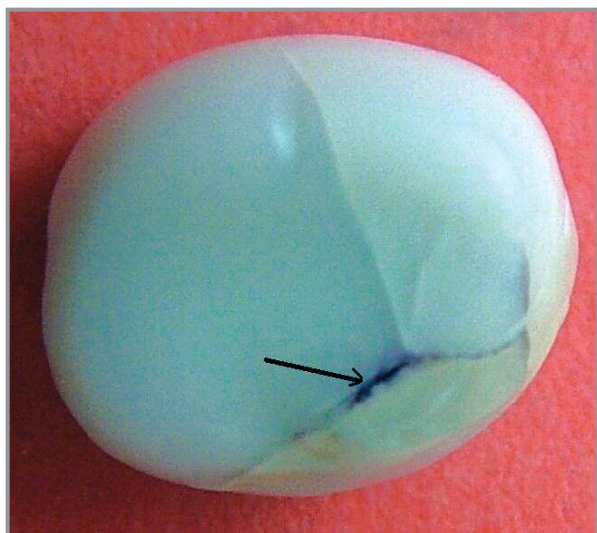
Figure 1. Dye penetration between original veneer and repair material (see arrow).

Dye penetration between the original veneer and the repair material was seen in 20% of all specimens (Figure 1). All specimens in both repair groups showed similar dye penetration, and there was no significant difference between the groups ( $P = .38$ ).

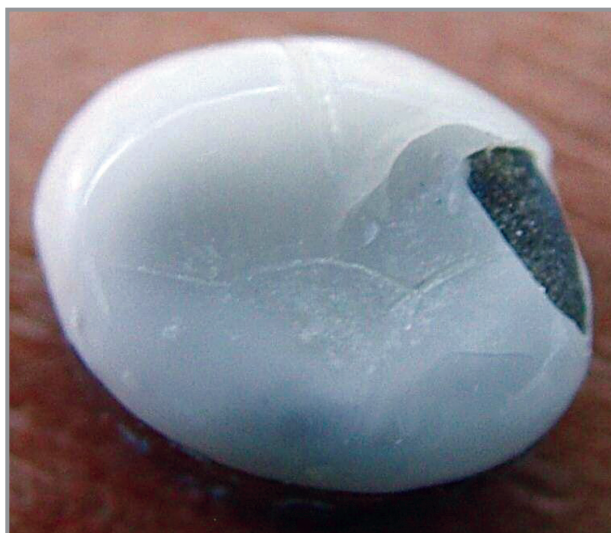
Figure 2. Extents of fractures varied among Class II and loss of one third of the original veneer material (original magnification X10).

**Shear bond strength of repaired crowns.** After dye penetration was evaluated, 20 of the repaired crowns were debonded in the test machine as described for the original SBS test. The force required was recorded in newtons as before. The debonding failure of the repaired crowns was also evaluated under the stereomicroscope at X10 magnification. The failure types observed for both repair materials were noted according to the following criteria: adhesive failure (dislodgement at the SSC and/or the original veneer resin interface); cohesive failure (failures within the repairing materials); or adhesive/cohesive failure (mixed). In addition, the extent of fracture of the original veneer and both repair materials were examined as a whole, composed of the occlusal and vestibular parts, and was easily classified as follows: 1) no loss, but cracking visible; 2) loss of one third; 3) loss of one half; and 4) complete loss.

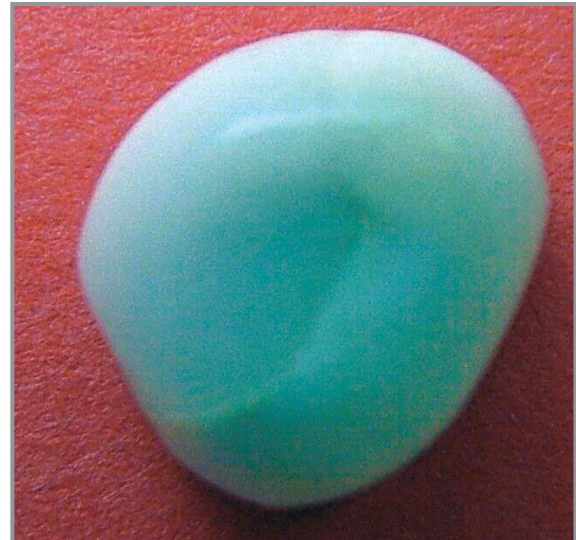
Figure 6. Preveneered stainless steel crown repaired with Monoopaque (original magnification X10).

Sections of 2 repaired crowns were evaluated under SEM and photomicrographs were obtained (Figures 3-5). No gaps were seen at the interface between the original or repair materials and the sandblasted stainless steel base (Figures 3 and 4). In addition, the interface between the original veneer and the repair materials showed an intimate adaptation (Figure 5). Both repair methods gave similar esthetic results (Figure 6).

Both repair methods used in this study (Panavia opaque cement and Tetric Flow or Monoopaque and Tetric Flow) gave similar esthetic results because of the high power of the sealing of the opaques. In a clinical situation in which fractures of veneered SSCs are experienced, either repair material used in this study may be used.
