White spot formation associated with sealants used in orthodontics

Abstract

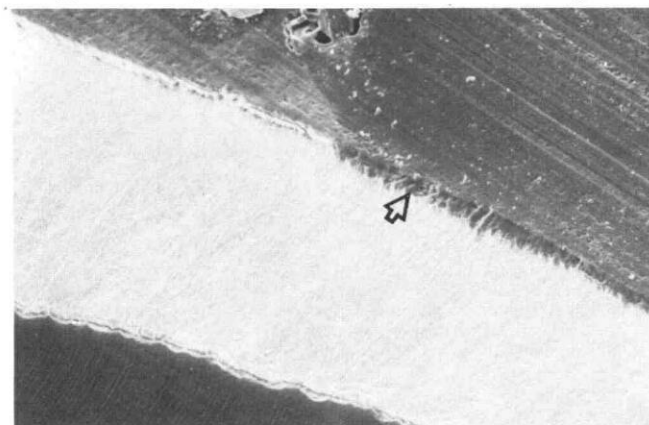
Figure 3. Scanning electron micrograph showing lesion infiltrated with embedding resin (arrow). Original magification x 80.

adjacent to, and occasionally below, the bonding resin. The spaces created during white spot formation were infiltrated with the embedding resin. In Figure 3, the resin is shown in relief following partial demineralization of the enamel during specimen preparation.

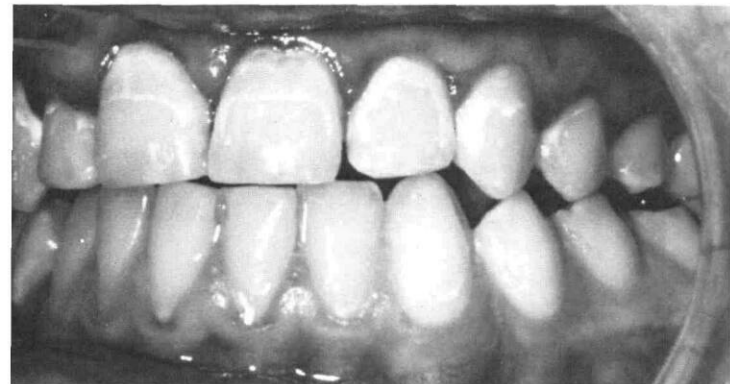
Figure 6. Upper anterior segment showing typical arc-shaped lesions of enamel demineralization associated with bonded brackets.

studies have formed the basis for these recommendations⁹ much equivocation exists on the subject. Pits and fissures sealed with resins have shown significant reductions in the caries attack rate for the occlusal site.¹⁰ However, the application of some of these same sealants has failed to provide consistent protection against white spot formation on smooth tooth surfaces immediately adjacent to bonded orthodontic brackets (Figure 6).
